**PORT ASSESSMENT REPORT**  
**At the Port of Buchanan**

Date and hour: 27.11.2003 / 1230 to 1315 LmT

**Performed by Capt. Eric F. Mora B.**  
**WFP Port Captain**

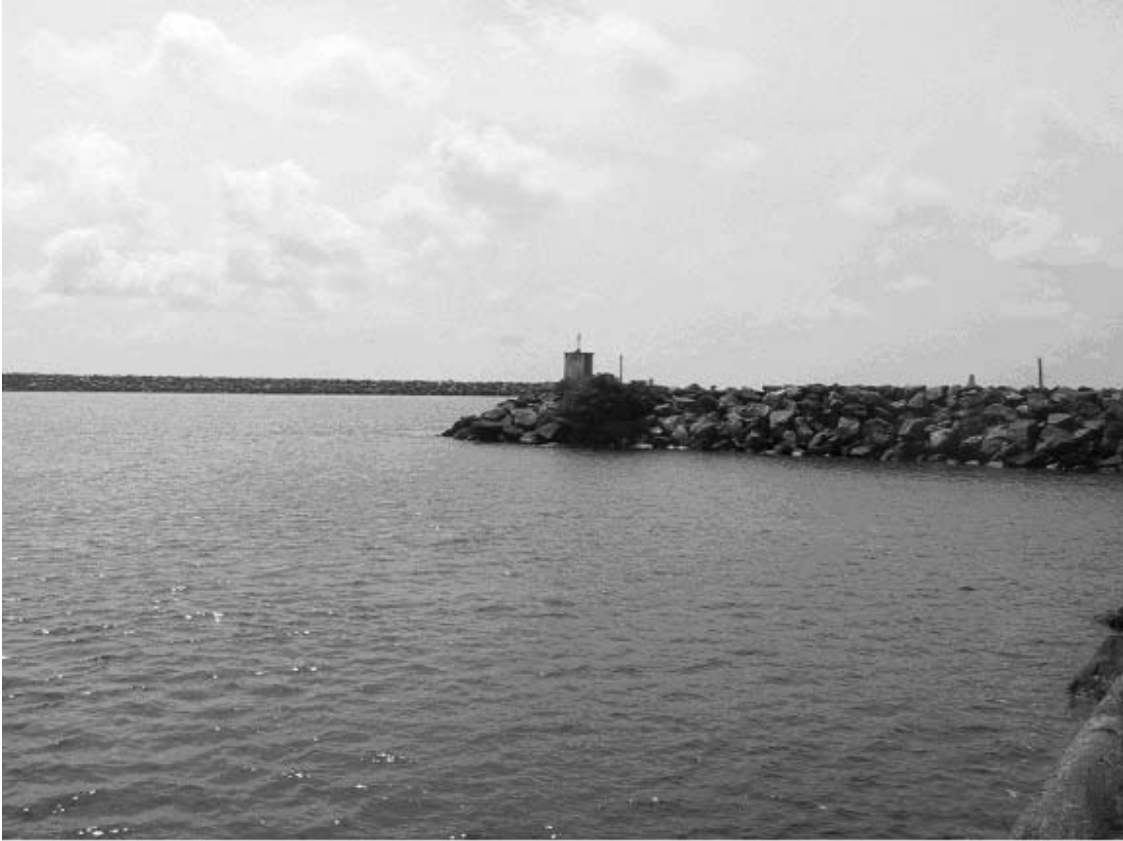
A light is exhibited from white square concrete towers standing at the heads of both breakwaters. The towers are normally floodlit at night but the working conditions were not checked due to be present during daytime.

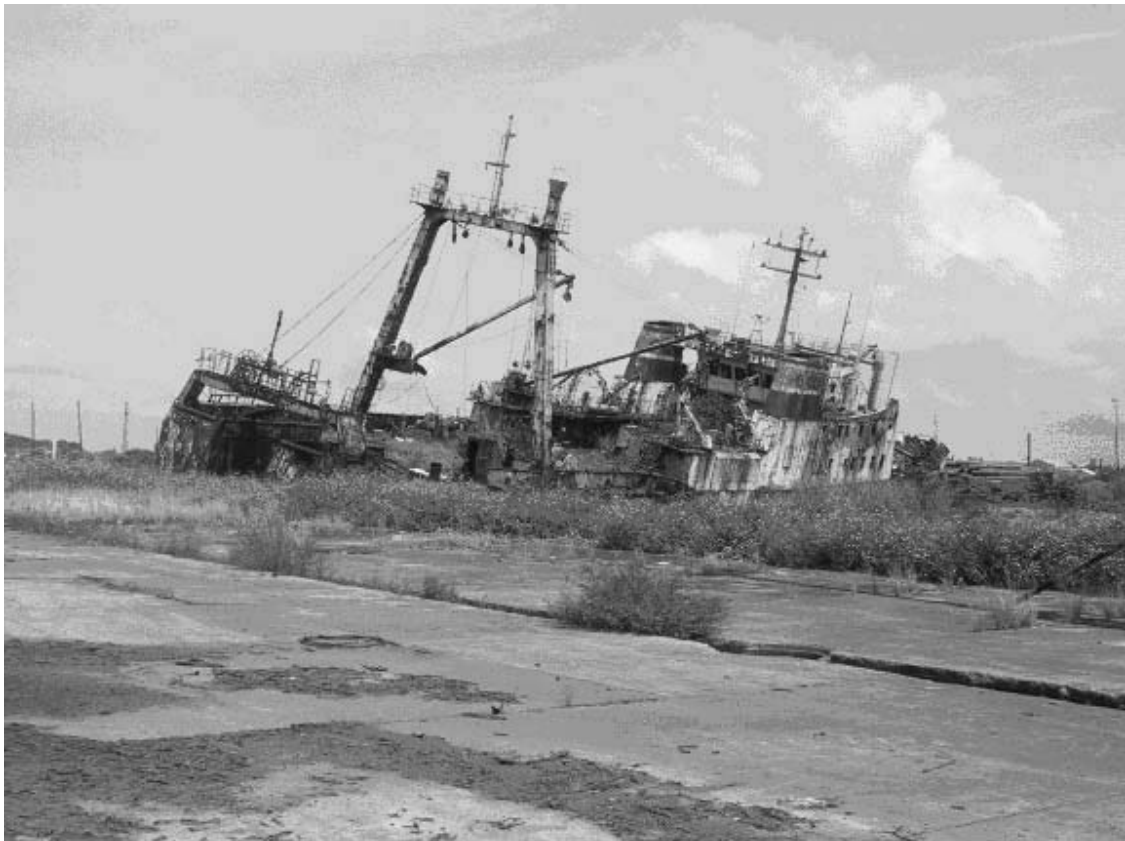
Other three visible wrecks were observed in the inner bay, one aground in the north extreme of the port, the m/v “Coyssy IV”, and other two aground in the beach northwest from the Ore Pier. All three wrecks do not represent a hazard to navigation due to be out of the traffic zone.

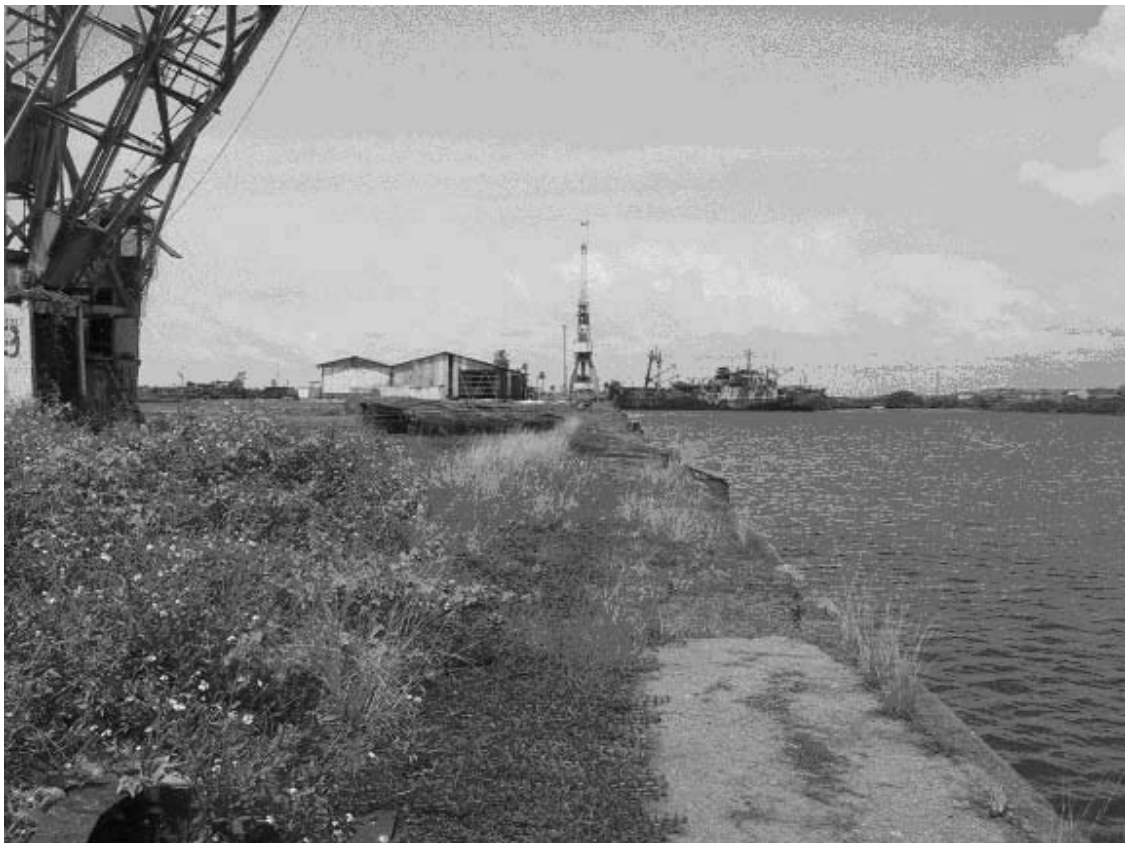
The Commercial / General Cargo Quay was visually inspected and was found in good and solid state, all 17 bollards in place, and well provided with fenders, being tractor tires fixed with chains the most of them.

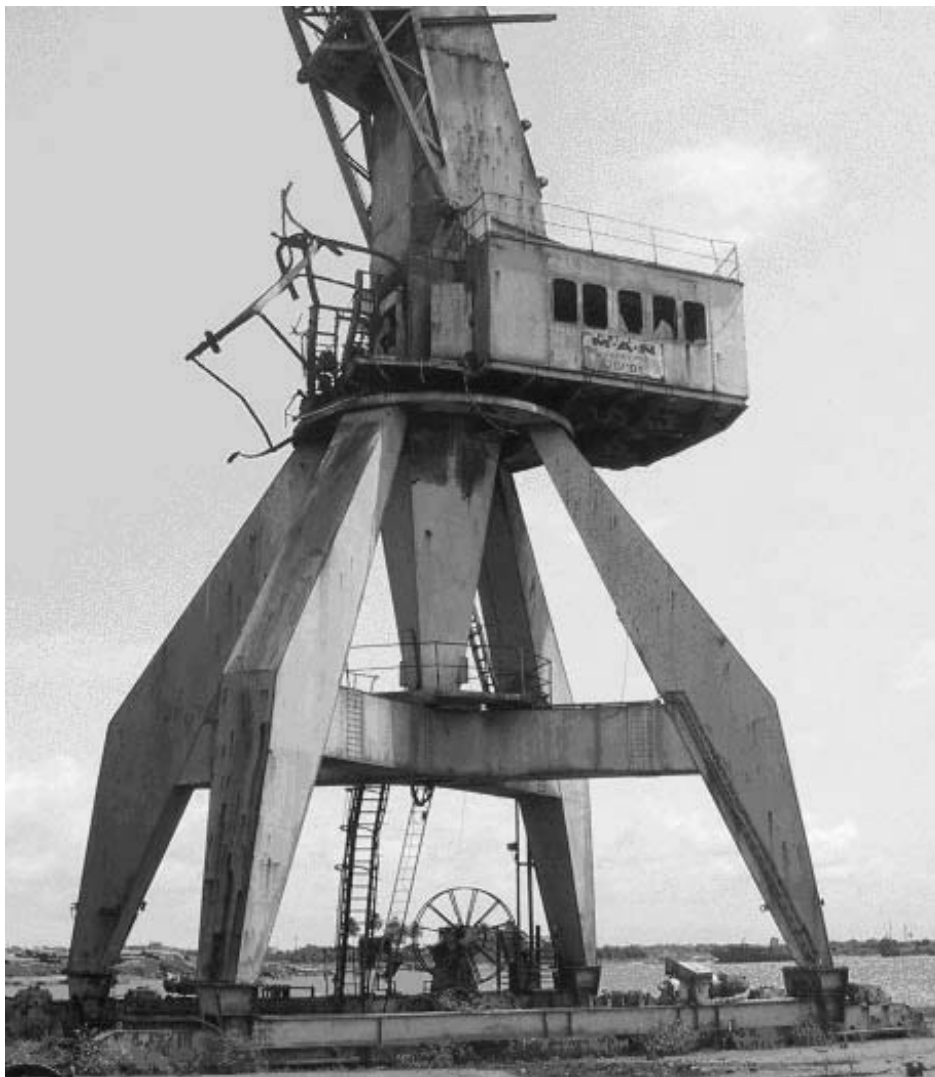
The port is fitted with a 20/10 MT SWL capacity shore crane located in the Commercial / General Cargo Pier (mobile / rail mounted). Nevertheless was found in advanced state of destruction due to lack of use and maintenance, and due to most of the parts have been removed. At the time of the survey at least two persons were inside removing parts / looting.

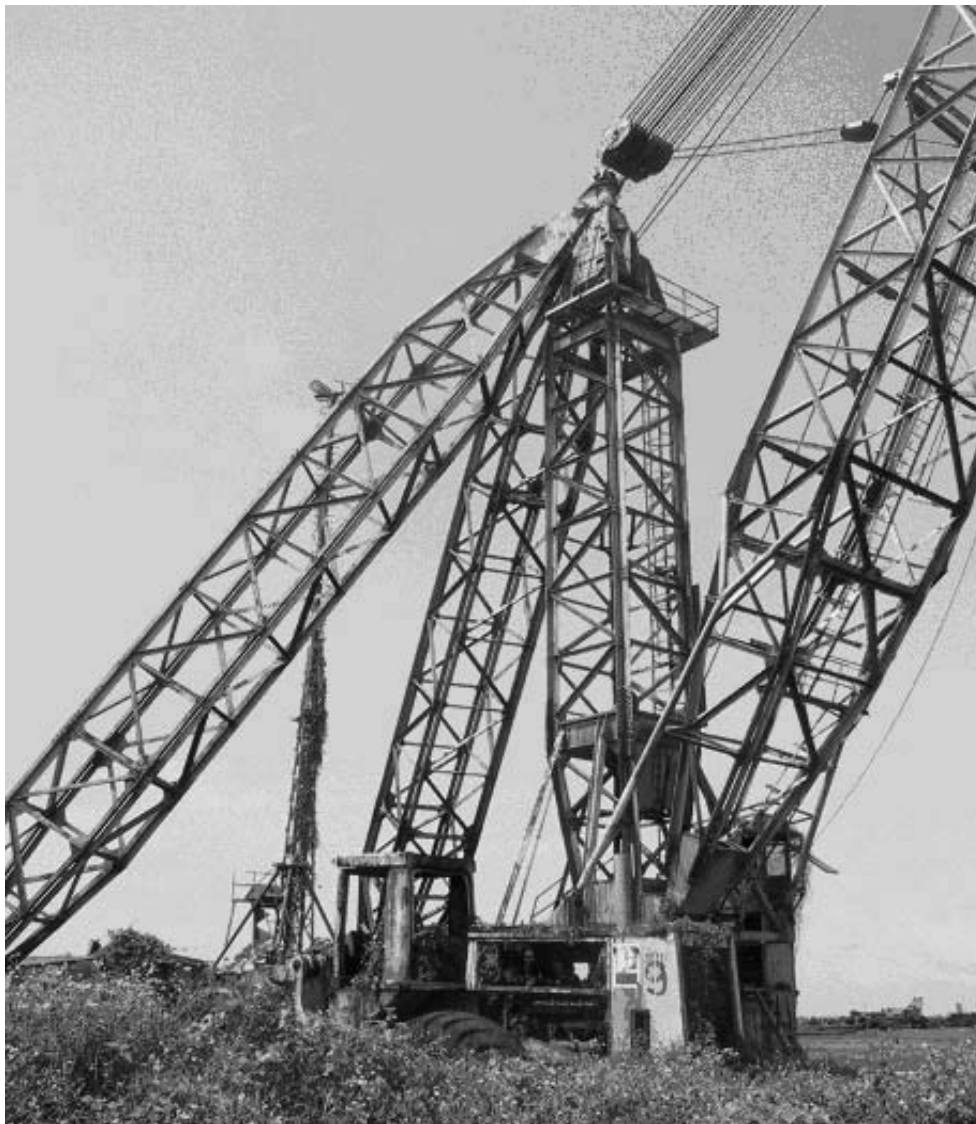
At the southern extreme of the Commercial Pier was found a fix shore crane of unknown SWL Capacity. Due to the proximity of the loading log yard and the type of crane it is believed to be used for loading logs in vessels. Due to the abandoned condition and the massive destruction of the operation cabin high costs are estimated for its recovery.

A log-handling payloader in apparent non-recoverable state was also found in the southern extreme of the commercial pier.

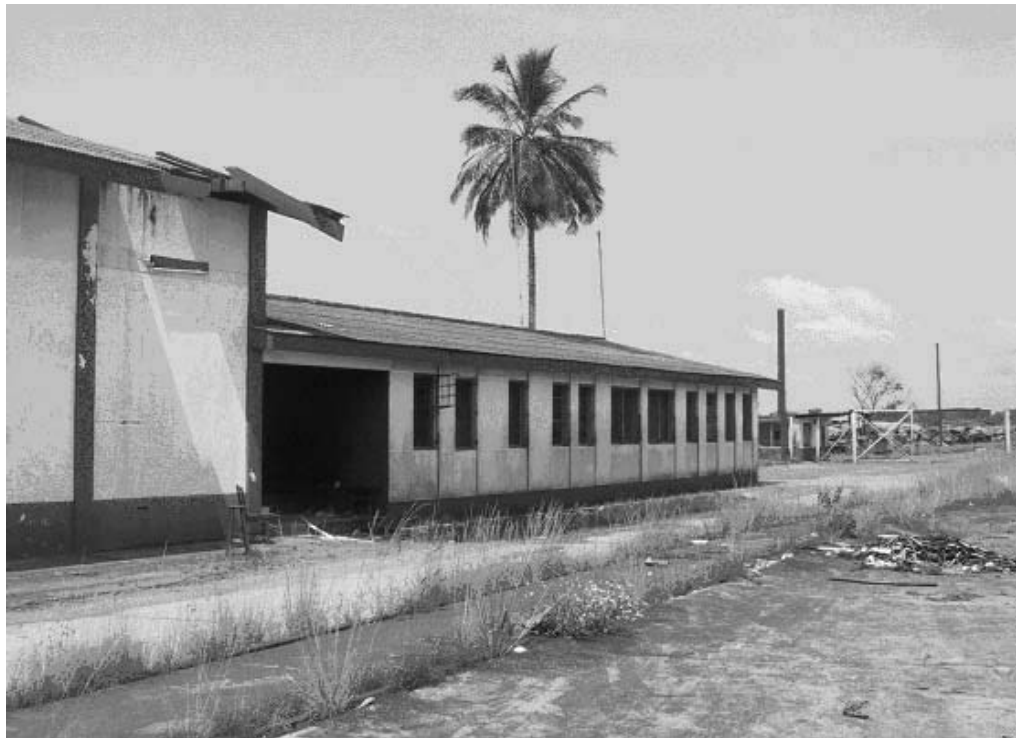
- Security / Gate Office: Medium grade of destruction. Windows broken or removed.
- Administration Building: Low grade of destruction. Only damages are windows broken or removed. All furniture including the air conditioning units were removed. Minor repairs and painting are needed.

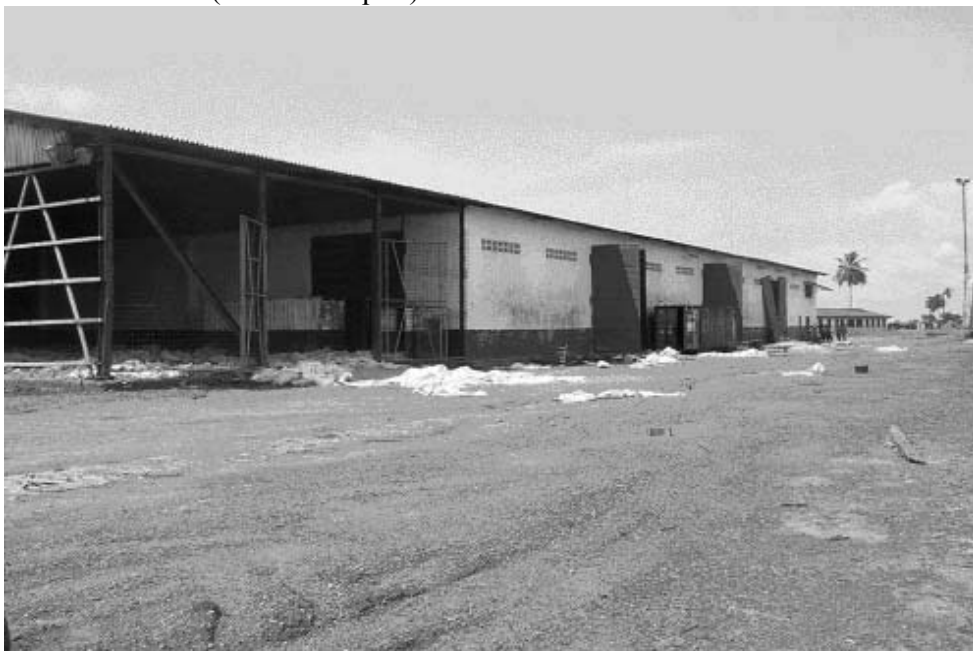
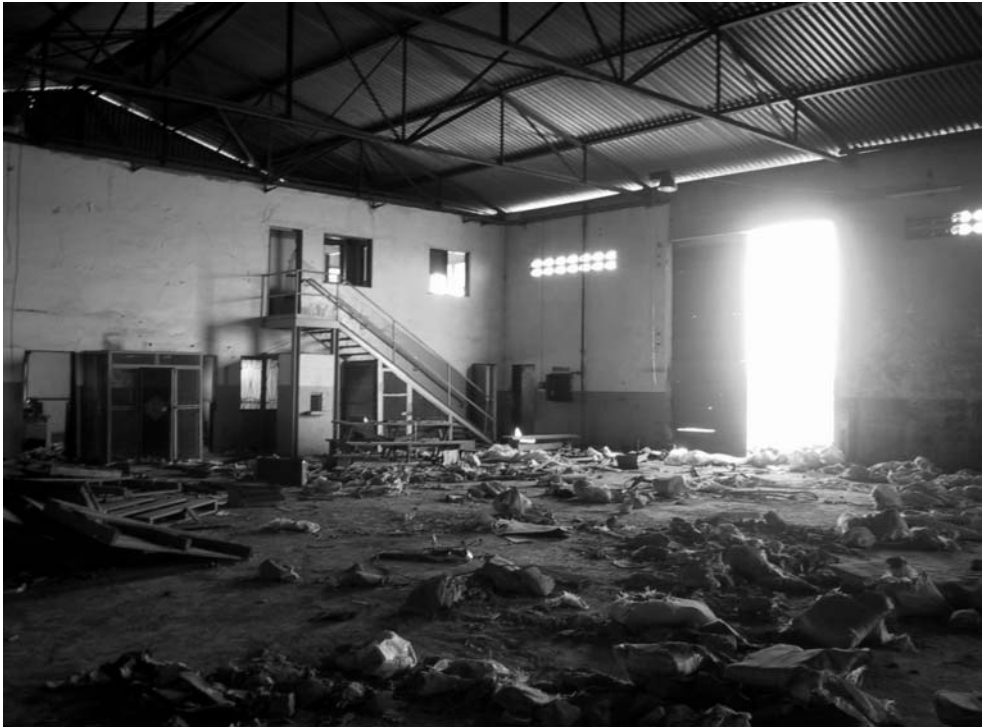
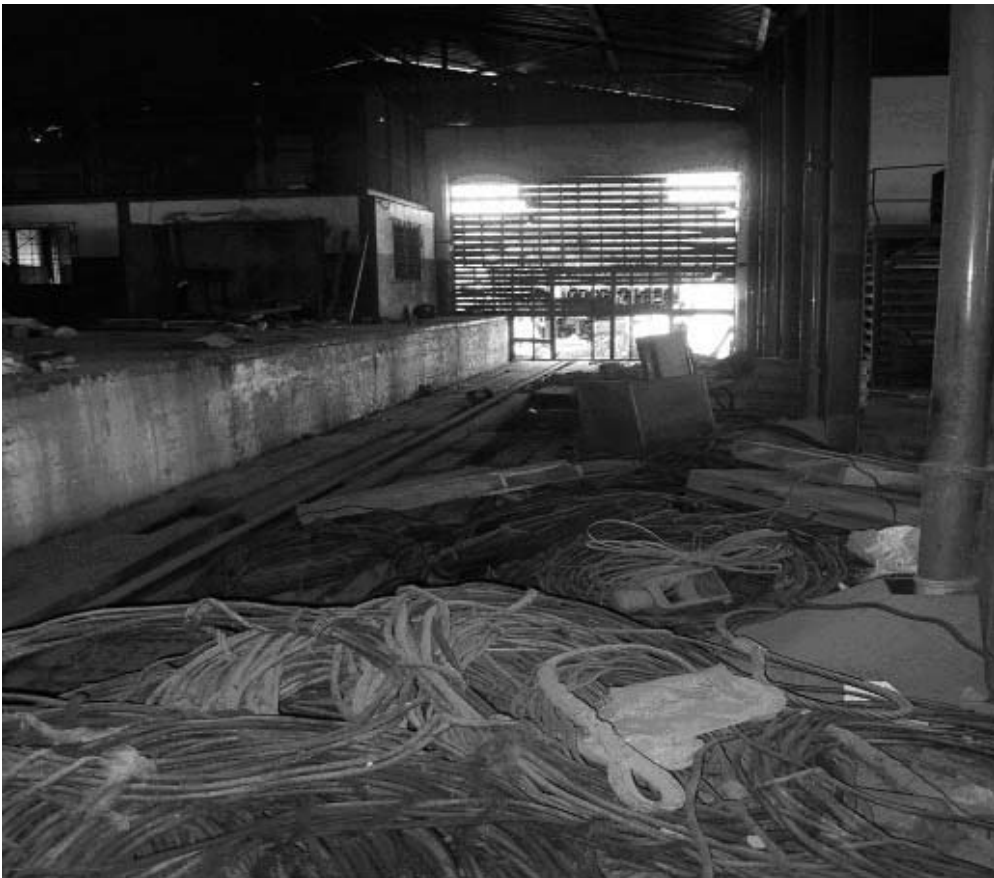
- Administration Warehouse: Low grade of destruction. Provided with four consecutive metallic gates in apparent good state. The roof is also in apparent good state. Found with many debris inside (apparently broken solidified cement bags) and with a forklift and a tractor in scrap state. Approximate dimensions: 11 x 27 meters (abt 300 Sq.m.)

- Authorities Building: Low grade of destruction. Only damages are windows broken or removed. All furniture including the air conditioning units were removed. Minor repairs and painting are needed.

- Workshop: High grade of destruction. Roof entirely removed. Electric wiring destroyed. All machinery and tools removed.
- Workshop Offices: High grade of destruction. The roof is destroyed as well as some walls. Found with apparent structural damages. The building is probably non-recoverable or at least more expensive to recover than constructing a new one.

- Cargo Warehouse: Medium grade of destruction. The roof is in general good state just needing some minor repairs for small holes. It is provided with five gates, three facing the pier, one for the railroad access, and one for access to the annex. One of the gates facing the pier is in need of repair. The gate for the road is missing and replaced by an improvised fix wooden wall. The four ground floor, and the four first floor warehouse offices were found in messy conditions and with all furniture removed but in need only of minor repairs. In general the warehouse was found in structural regular state but in messy conditions with wires, old spare parts, wires and debris spread all around. Approximate dimensions: 60 x 34 meters (abt 2000 Sq.m.)

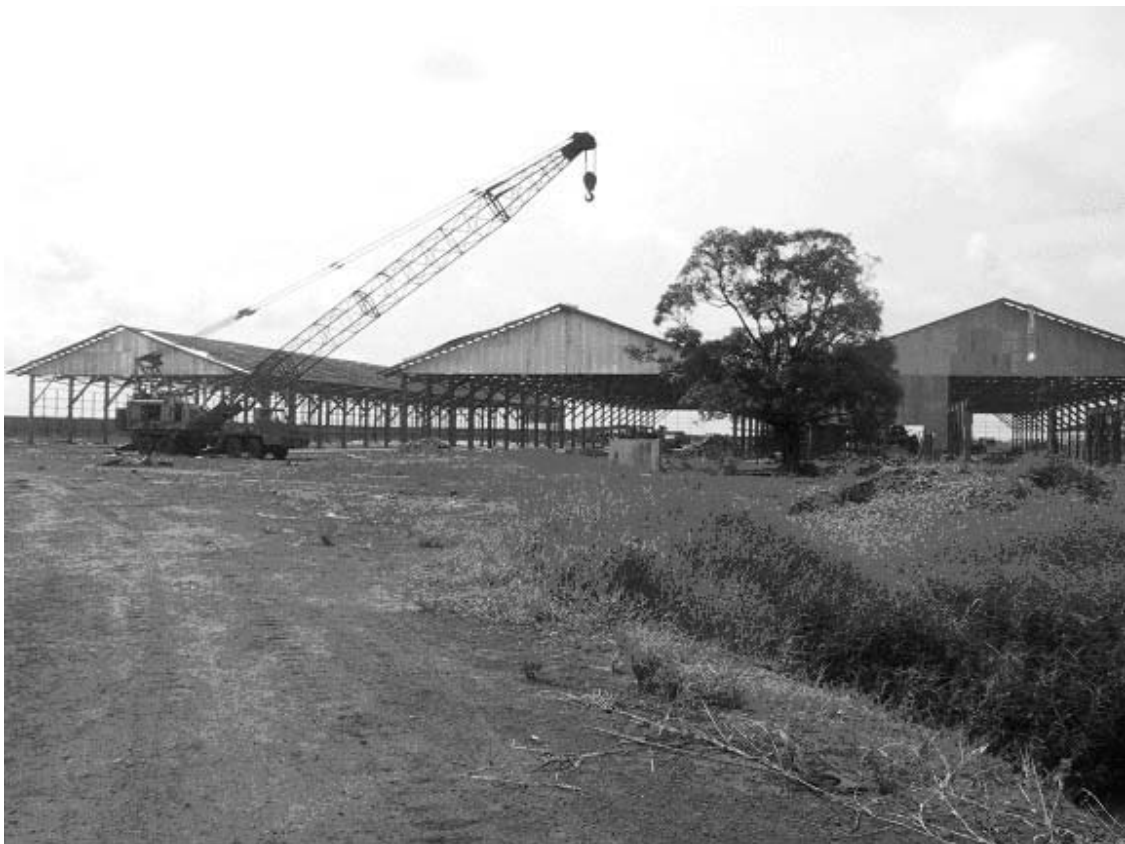
Each of the warehouses is of approximately 120 x 45 meters (abt 5000 Sq.m.) and were found with the wooden structure intact. Nevertheless the most of the zinc plating that constituted the roof and the walls was removed, most probably looted.

Different types of heavy work machinery were found in the center warehouse and in the surroundings.
