Mosul Dam Mission Report

17 August 2016

The mission's purpose was to understand from the Dam officials their views regarding the structural threats present at the Dam.

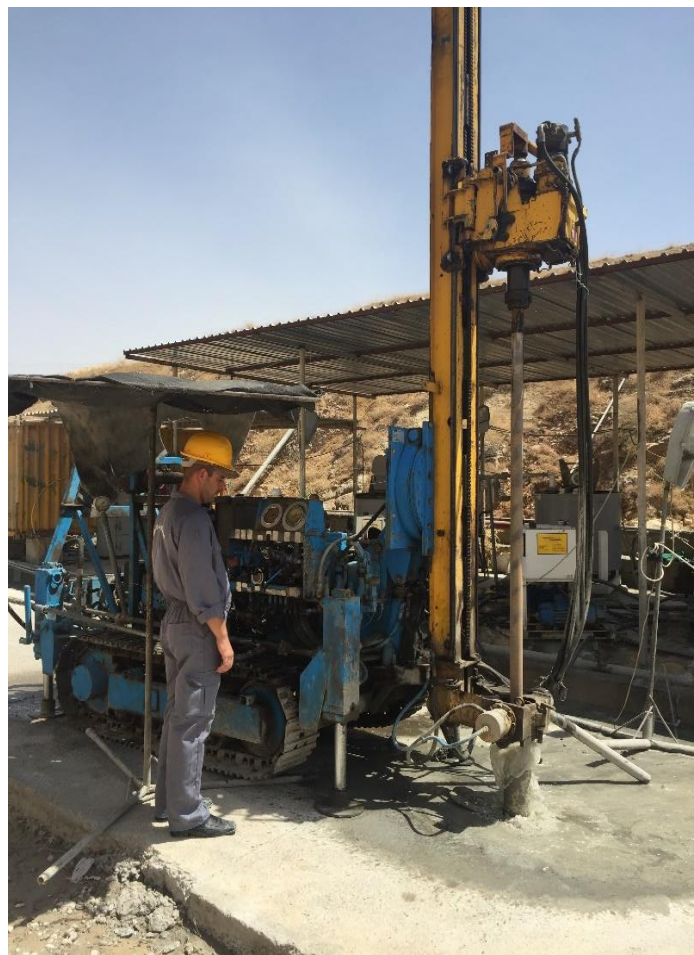
Figure 3: Grouting along the side of the Spillway Chute

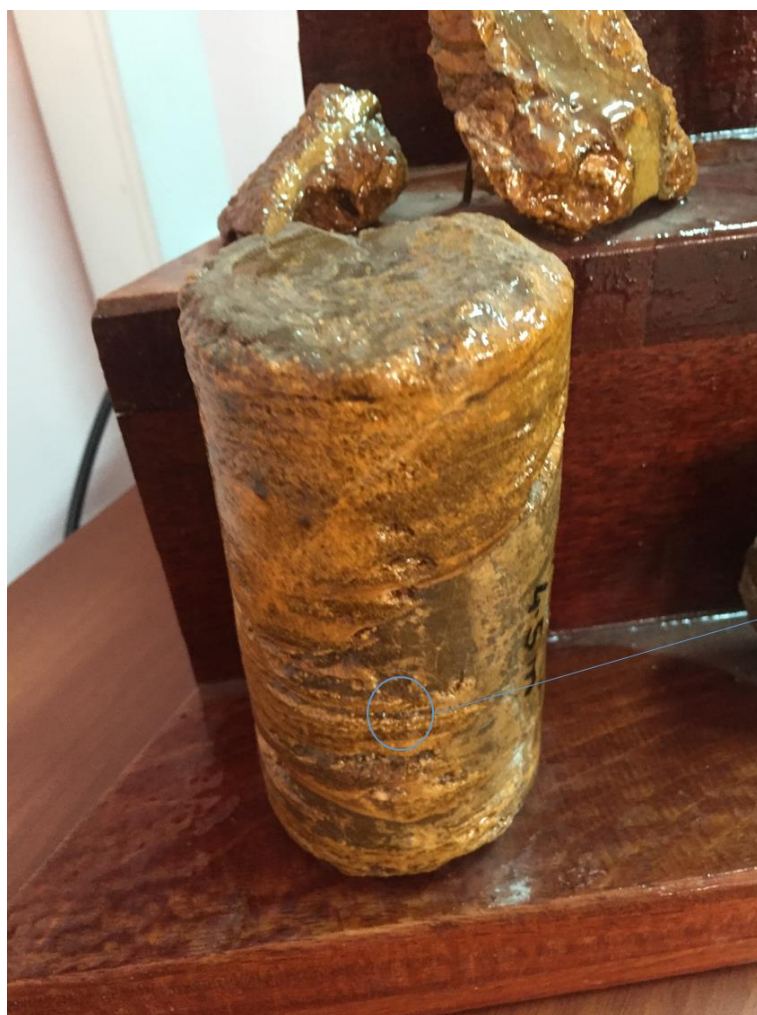
The voids are natural occurrence due to the geological composition of the soil which has soluble layers below dam level. This risk is mitigated through grouting activities under the Dam. Due to extensive grouting activity regularly being implemented, the voids should not present any real danger to the Dam. The pressure being applied to pump the cement mixture is reaching the smallest voids as illustrated by available samples.

Figure 4: Sediment samples showing effect of grouting

Sediment sample showing
cement in very small cavities

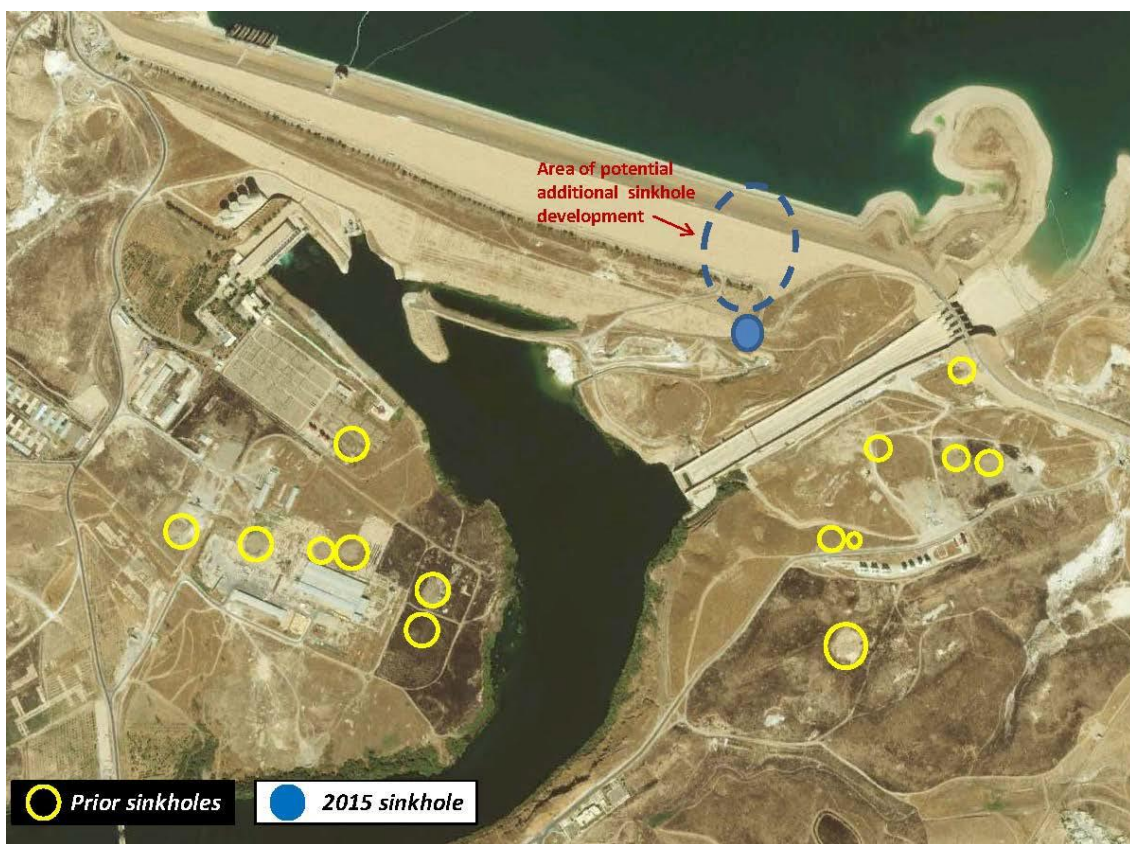
The Director pointed out on the model of the Dam that the sinkholes are present on the right side of the Dam, down the land bordering the channel produced by the power station; those sinkholes are caused by the water flow coming from beyond the lake, not directly caused by the Dam reservoir. The Schnabel report though indicates sinkholes development nearer to the Dam, but those were not commented upon during the visit. However, as mentioned before, grouting near the Chute alley has started.

Figure 5: Recent sinkhole development - Schnabel report 2016, p 20.

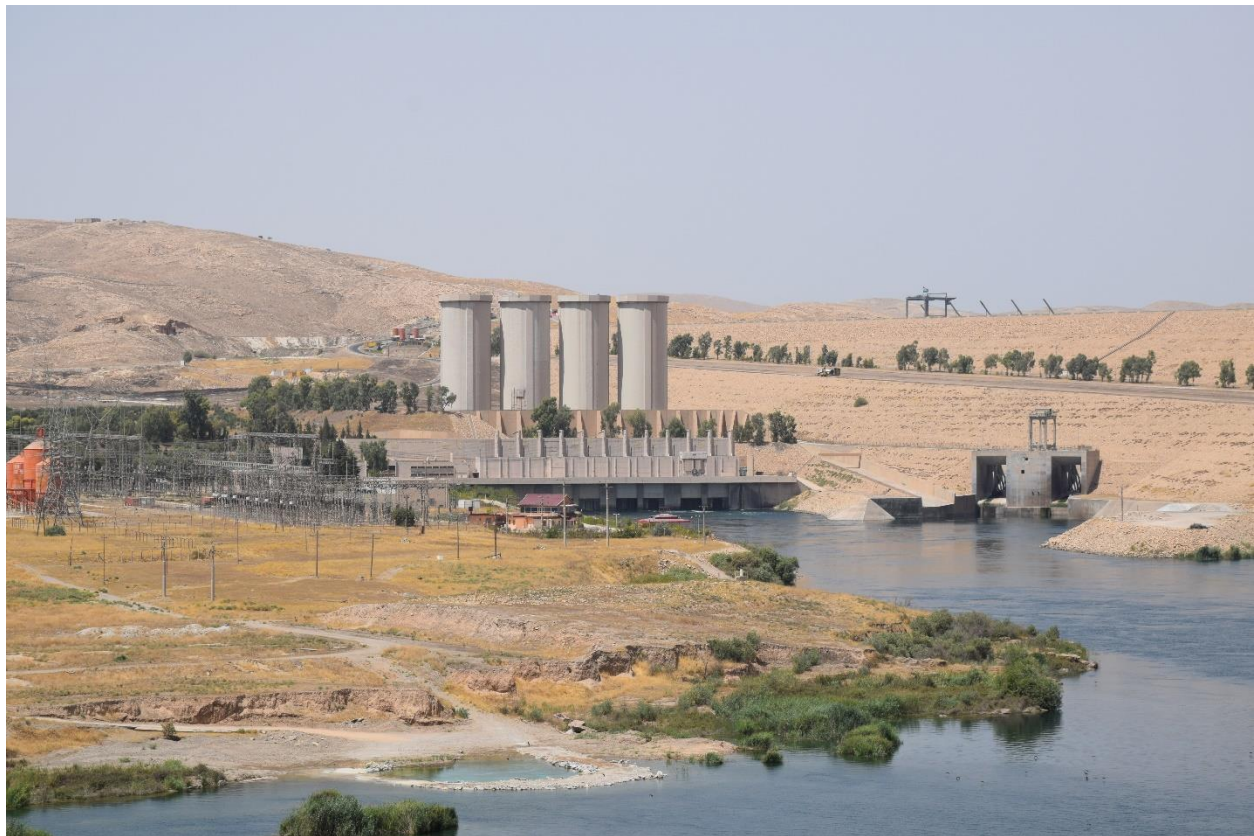
The left gate is a cause for concern as the bottom outlet are to be used to quickly lower the water level in the Dam in case of need; therefore, it is a high priority for the Dam management. The contract signed with Trevi has a provision to fix the gate as part of their expected outputs.

Figure 6: The power station and bottom outlets
